RCRA Inspection Report

Pinewood Site Custodial Trust
8430 Camp Mac Boykin Road
Pinewood, South Carolina 29125-9733

EPA ID Number: SCD 070 375 985
NAICS Code: 562211

February 22, 2016

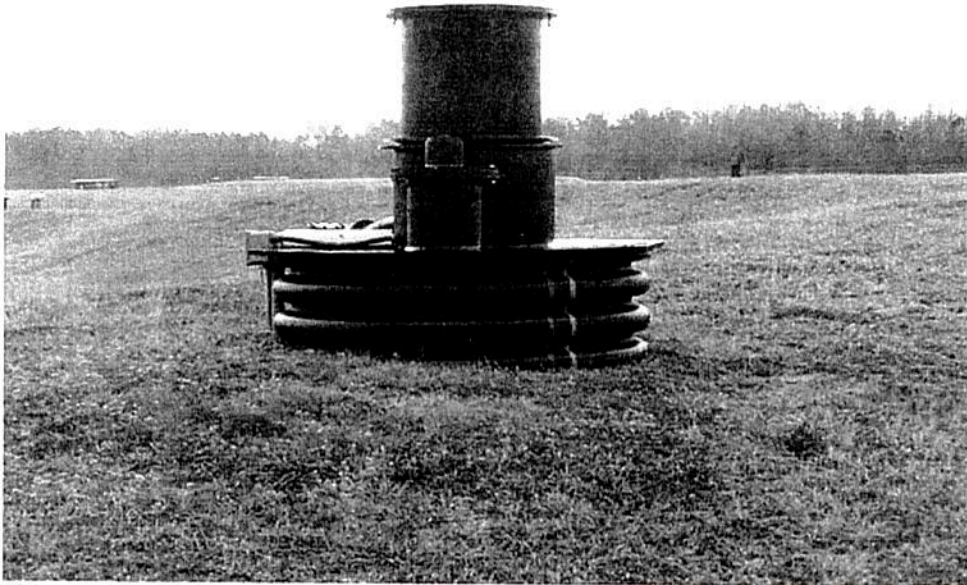
Picture 1: Primary leachate collection sump identified as I-C-1. Picture shows typical sump configuration. Picture taken by Keith Lane, SCDHEC, on behalf of EPA, on 2/22/16 at 1:49 pm

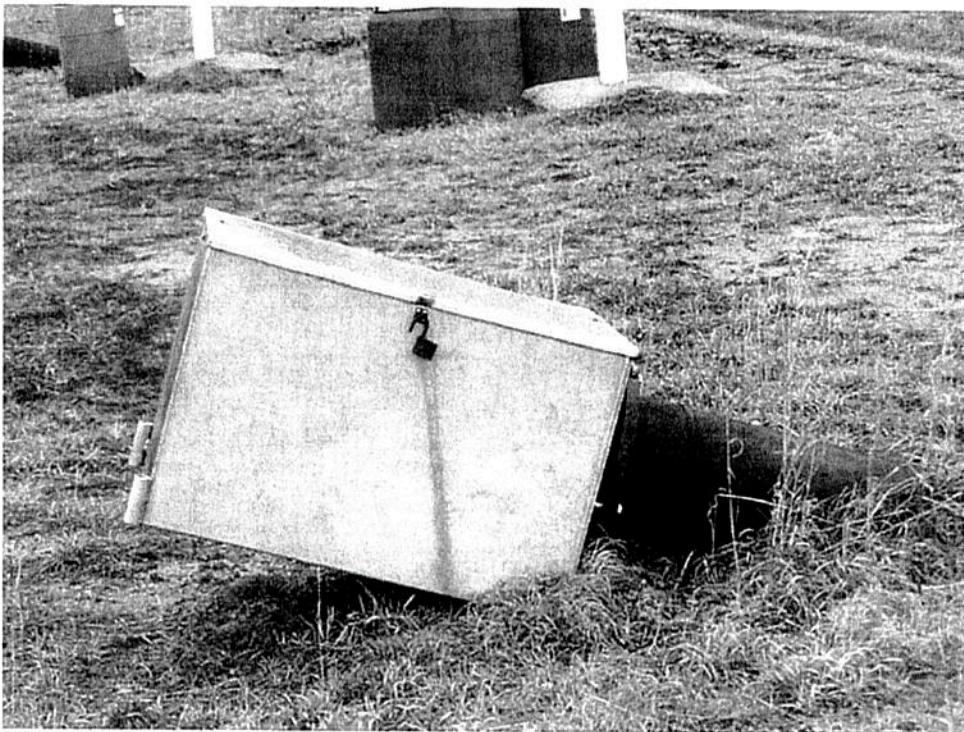
Picture 2: Vacuum truck connection point to secondary leachate collection sump. Picture shows typical sump configuration. Picture taken by Keith Lane, SCDHEC, on behalf of EPA, on 2/22/16, at 1:58 pm.

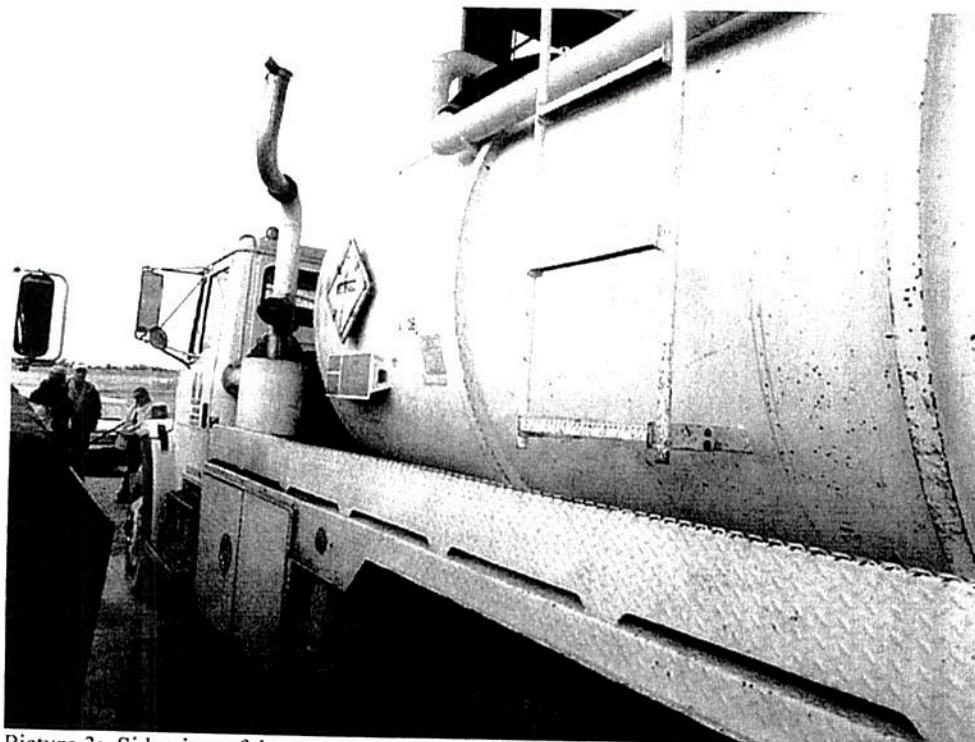
On the offloading pad, the inspectors observed one 3,000-gallon capacity vacuum truck and one 500-gallon capacity polyethylene container. The vacuum truck was reported to contain leachate pumped from the landfill’s secondary collection system. The truck was labeled as containing hazardous waste and dated with the accumulation start date of 1/29/16 (pictures 3 – 4). The accumulation start date represents the date on which the leachate was pumped from the sump. According to Pinewood officials, the polyethylene container contained liquids pumped from the

Picture 3: Side view of the vacuum truck parked on the concrete pad adjacent to the Central Tank Farm (CTF). The truck contained leachate from the secondary leachate collection system, which is pumped to one of the tanks in the CTF. Picture taken by Javier Garcia on 2/22/2016, at 2:05 pm.

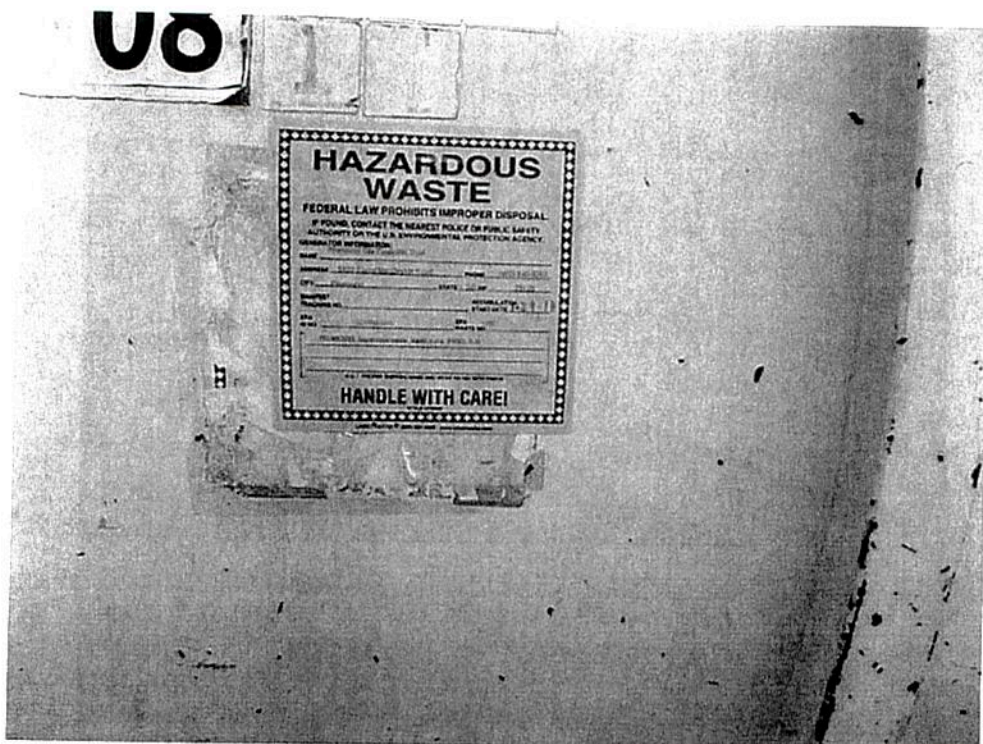
Picture 4: Close view of the hazardous waste label on the vacuum truck parked on the CTF's off-loading dock. Picture taken by Javier Garcia on 2/22/2016, at 2:05 pm.

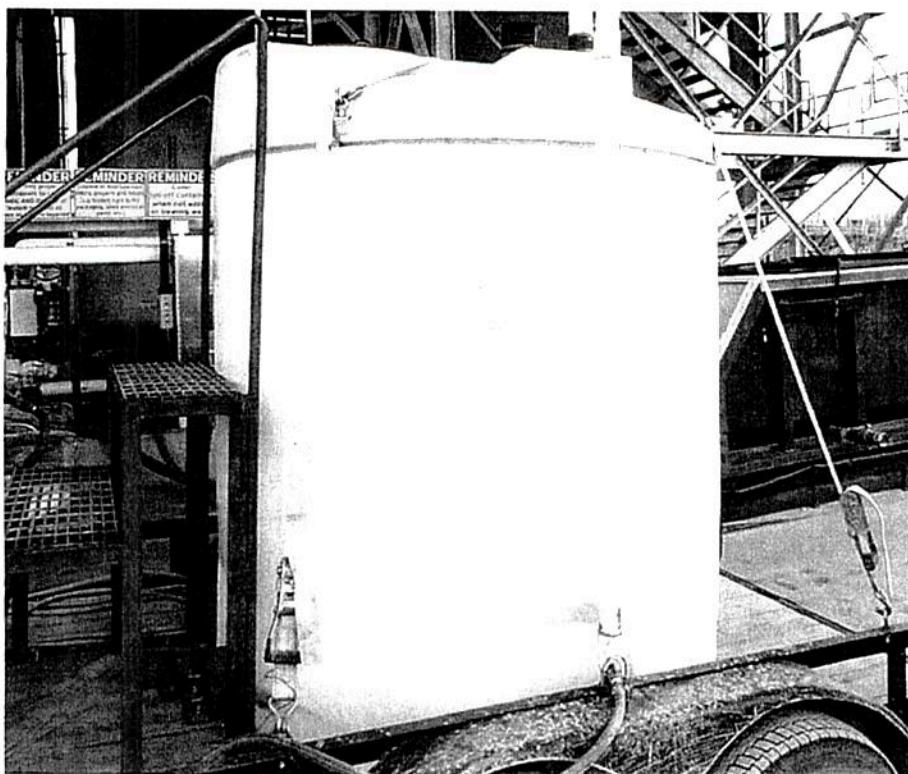
CTF secondary containment system. The container was labeled as containing hazardous waste and dated with the accumulation start date of 1/29/16 (pictures 5 – 6). In addition, the inspectors observed one 55-gallon container used for the accumulation of leachate-contaminated personal protective equipment (PPE) and debris generated on the pad. The container was properly labeled, closed and appeared to be in good condition (picture 7).

Picture 5: Polyethylene container parked on the concrete pad adjacent to the CTF. The container is used to collect liquids accumulated in the CTF's secondary containment system. Picture taken by Javier García on 2/22/2016, at 2:07 pm.

Picture 6: Close view of the hazardous waste label on the container shown in the previous picture (Picture 5). Picture taken by Javier García on 2/22/2016, at 2:07 pm.

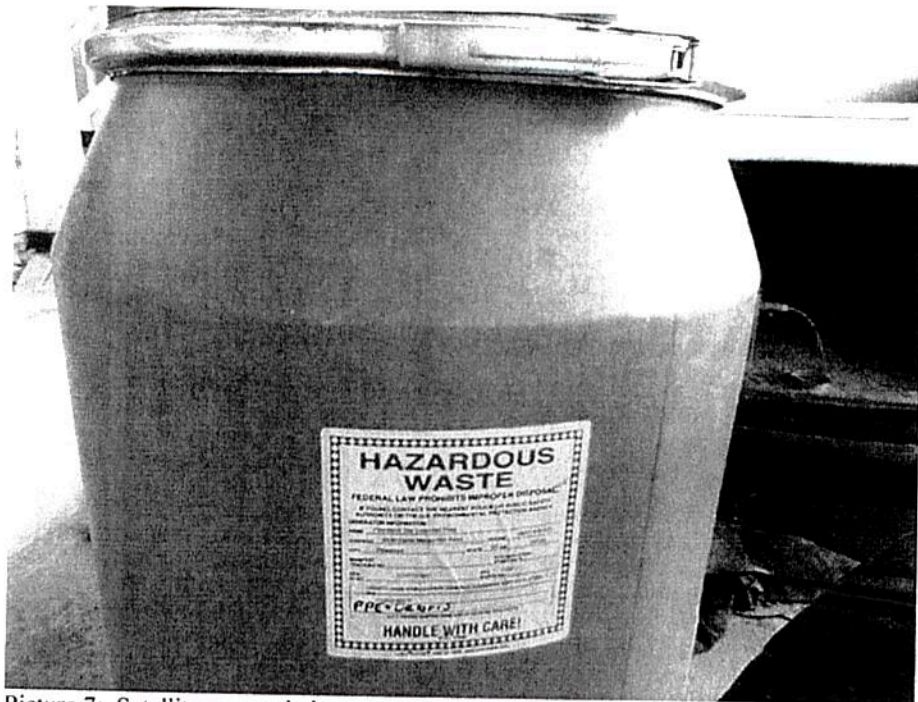
Picture 7: Satellite accumulation area container (SAA) on the concrete pad adjacent to the CTF. The container is used for the accumulation of hazardous waste (F039) contaminated personal protection equipment. Picture taken by Javier Garcia on 2/22/2016, at 2:08 pm.

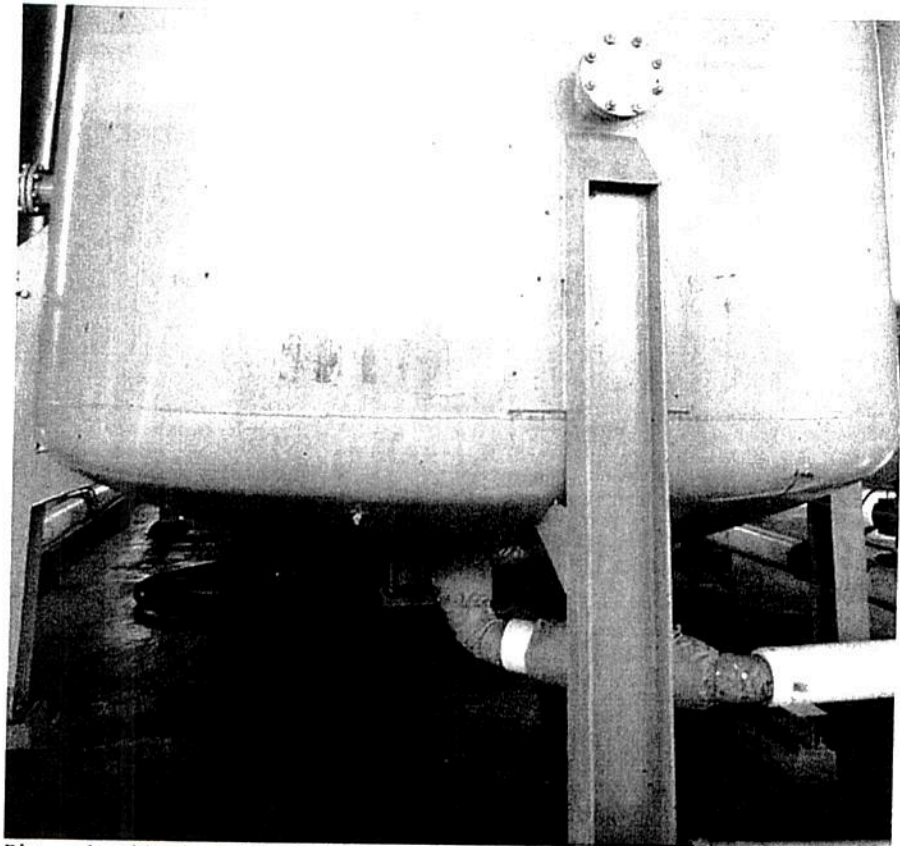
During the inspection, Mr. Burgess indicated that tanks #7, #8 and #9 were the only tanks that contained hazardous wastes. The remaining seven tanks were reported to be empty. The tanks in use were labeled as containing hazardous wastes and dated (pictures 8 – 13). The accumulation start dates observed on the tanks were as follows:

Picture 8: Side view of Tank # 7 at the CTF. Picture taken by Javier Garcia on 2/22/2016, at 2:12 pm.

Picture 9: Close-up of the hazardous waste label on Tank #7 in the CTF. Picture taken by Javier García on 2/22/2016, at 2:13 pm.

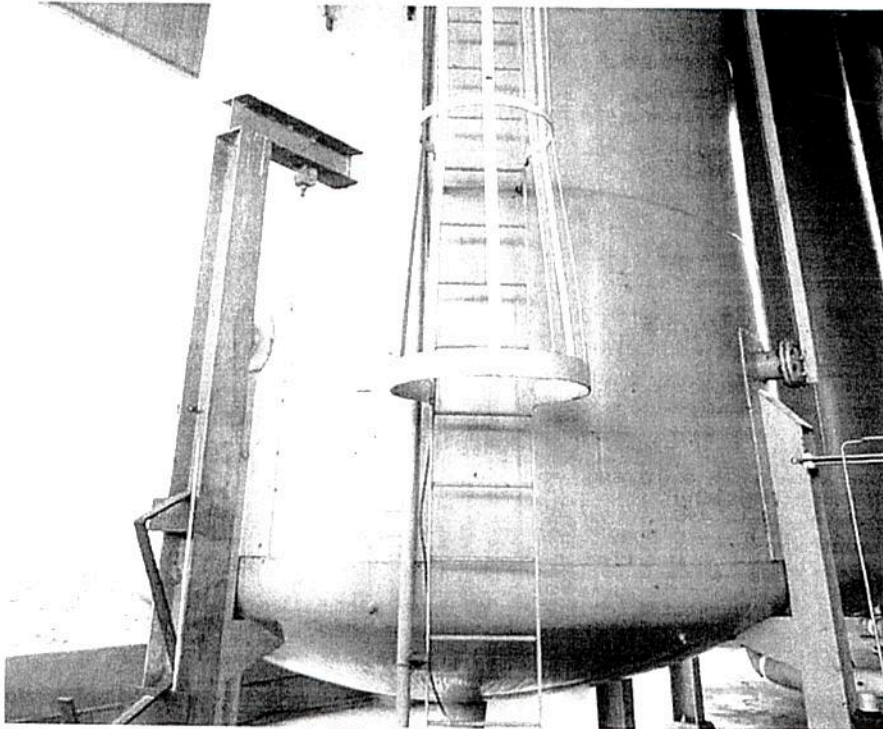
Picture 10: Side view of Tank # 8 in the CTF. Picture taken by Javier García on 2/22/2016, at 2:14 pm.

Picture 11: Close-up of hazardous waste label on Tank # 8 at the CTF. Picture taken by Javier Garcia on 2/22/2016, at 2:14 pm.

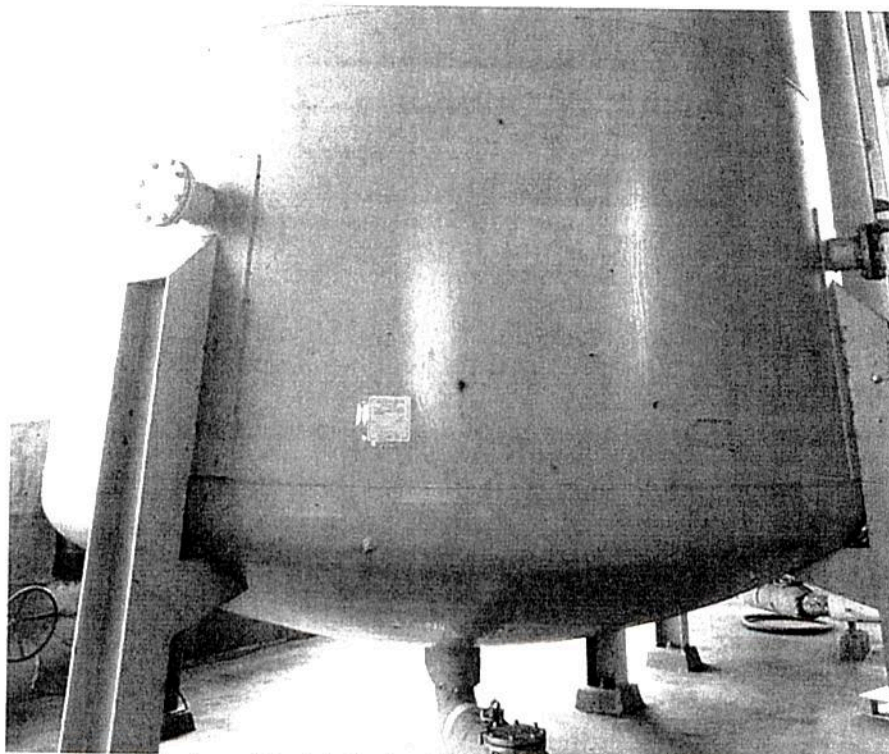
Picture 12: Side view of Tank # 9 in the CTF. Picture taken by Javier Garcia on 2/22/2016, at 2:15 pm.

Picture 13: Close up of hazardous waste label on Tank # 9 in the CTF. Picture taken by Javier Garcia on 2/22/2016, at 2:15 pm.

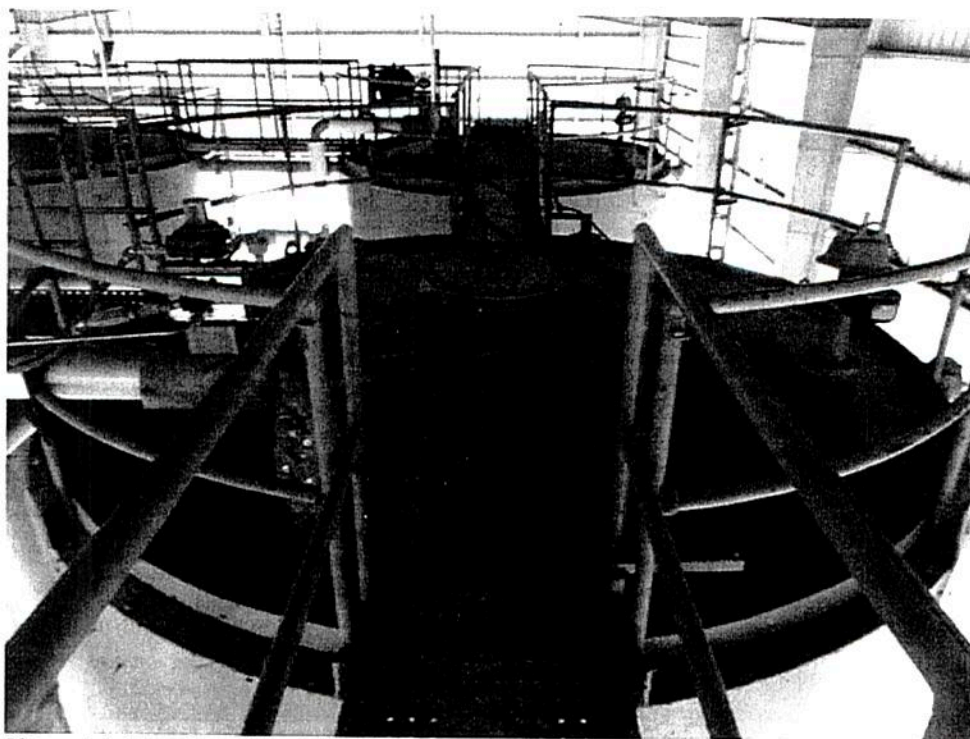
All tank openings and manholes appeared to be properly closed (pictures 14 – 16). The floor of the tank farm secondary containment system had small spots with cracks in the concrete and the sealant (pictures 17 – 21).

Picture 14: Top view of Tank #9. Picture taken by Javier Garcia on 2/22/2016, at 2:18 pm.

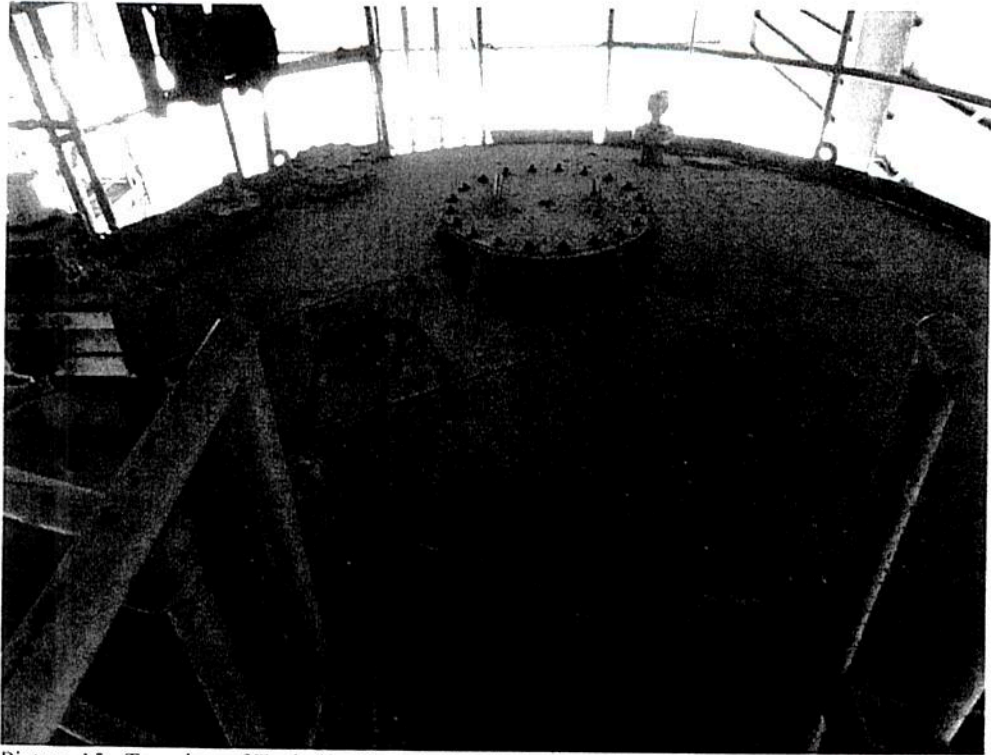
Picture 15: Top view of Tank #8. Picture taken by Javier Garcia on 2/22/2016, at 2:18 pm.

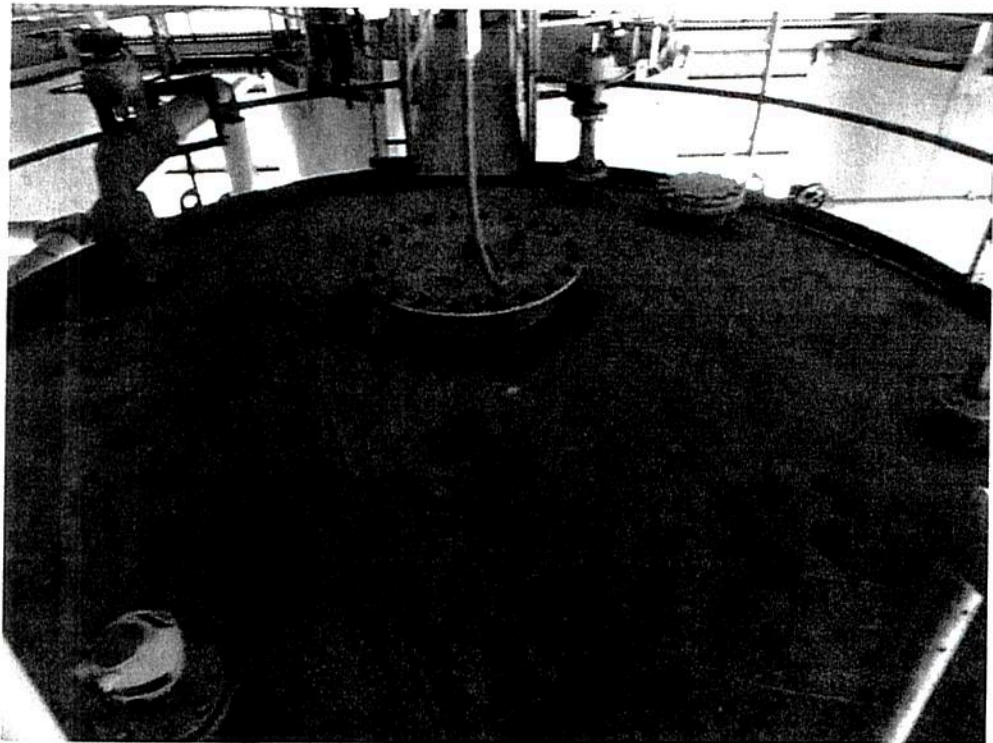
Picture 16: Top view of Tank #7. Picture taken by Javier Garcia on 2/22/2016, at 2:19 pm.

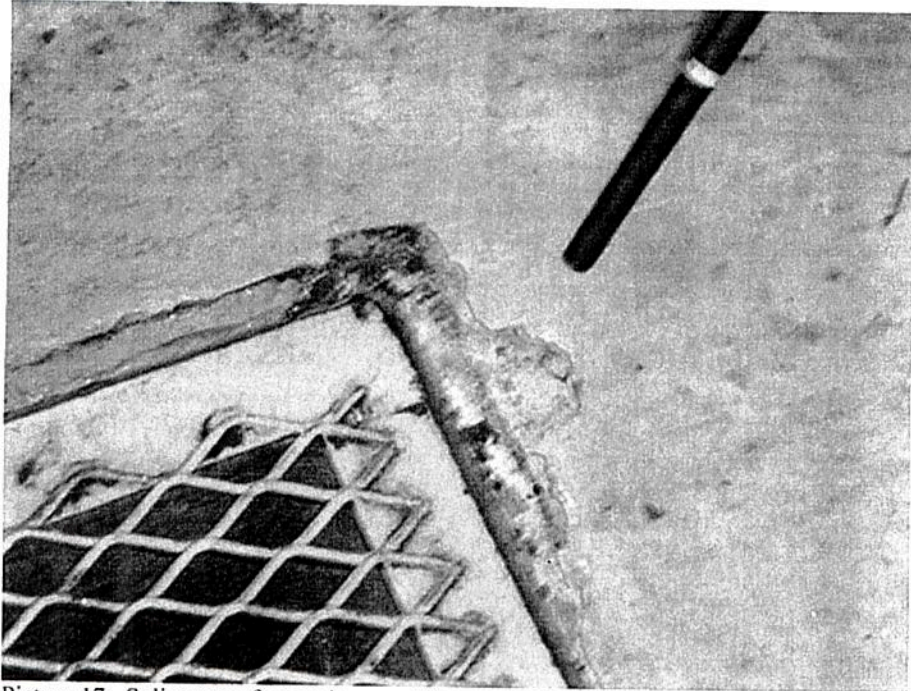
Pursuant to S.C. Code Ann. Regs. 61-79.262.34(a)(1)(ii) [40 C.F.R. § 262.34(a)(1)(ii)], which incorporates S.C. Code Ann. Regs. 61-79.265.193(e)(1)(iii) [40 C.F.R. § 265.193(e)(1)(iii)], a generator that stores hazardous waste in tanks shall maintain the secondary containment systems of its hazardous waste storage tanks free of cracks or gaps.

Picture 17: Split seam of secondary containment pad located in the northeast corner of the Central Tank Farm. Picture taken by SCDHEC on 2/22/16.

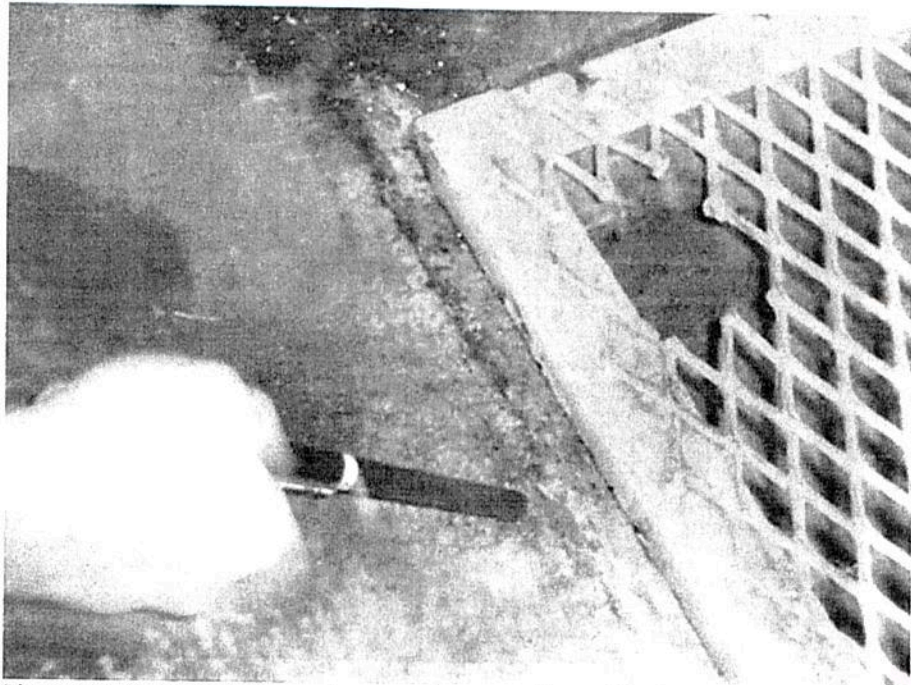
Picture 18: Split seam of secondary containment pad located in the southeast corner of Central Tank Farm. Picture taken by SCDHEC on 2/22/16.

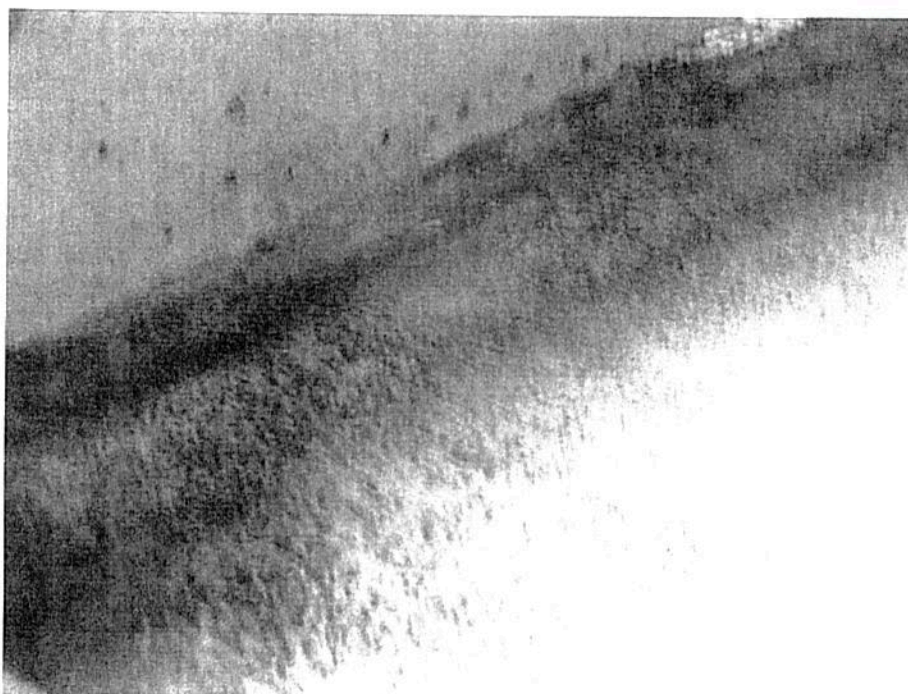
Picture 19: Bubbling of the sealant on the secondary containment pad along the north side of the Central Tank Farm. Picture taken by SCDHEC on 2/22/16.

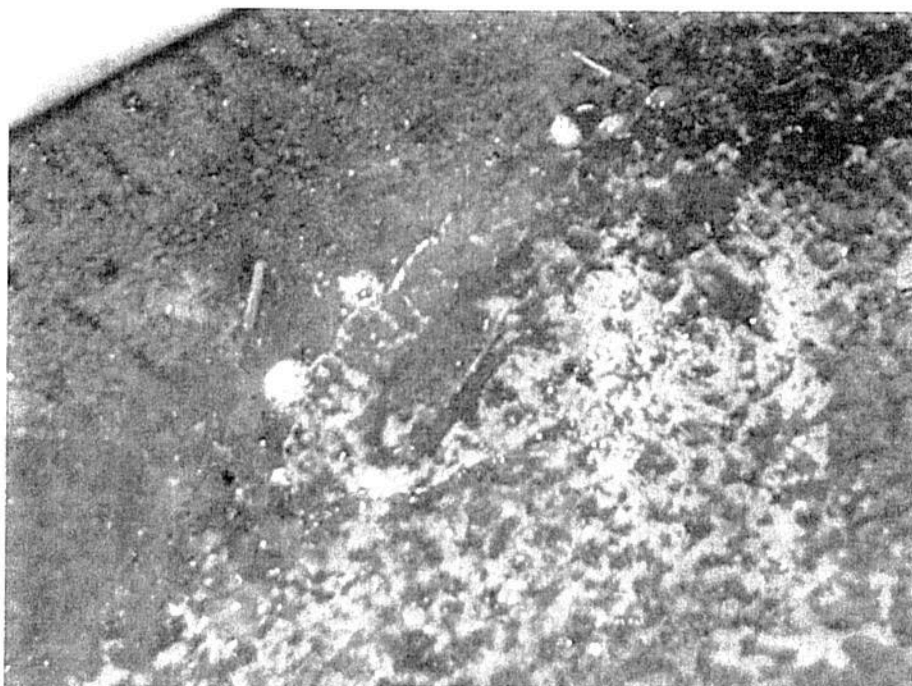
Picture 20: 6-inch crack near the center of Central Tank Farm's secondary containment pad. Picture taken by SCDHEC on 2/22/16.

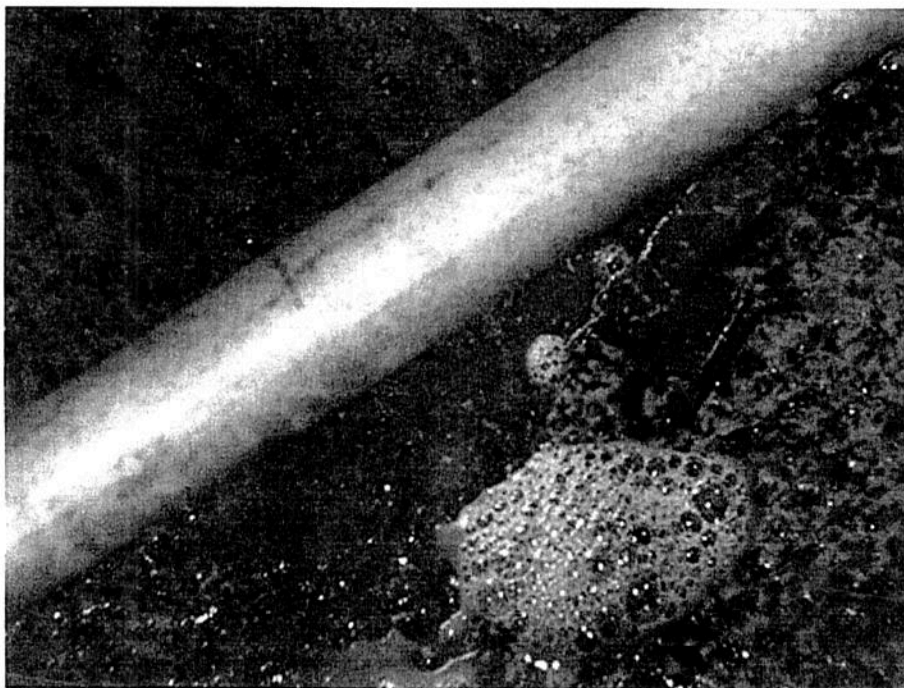
Picture 21: Closer view of the secondary containment pad crack shown in picture 11. Picture taken by SCDHEC on 2/22/16.

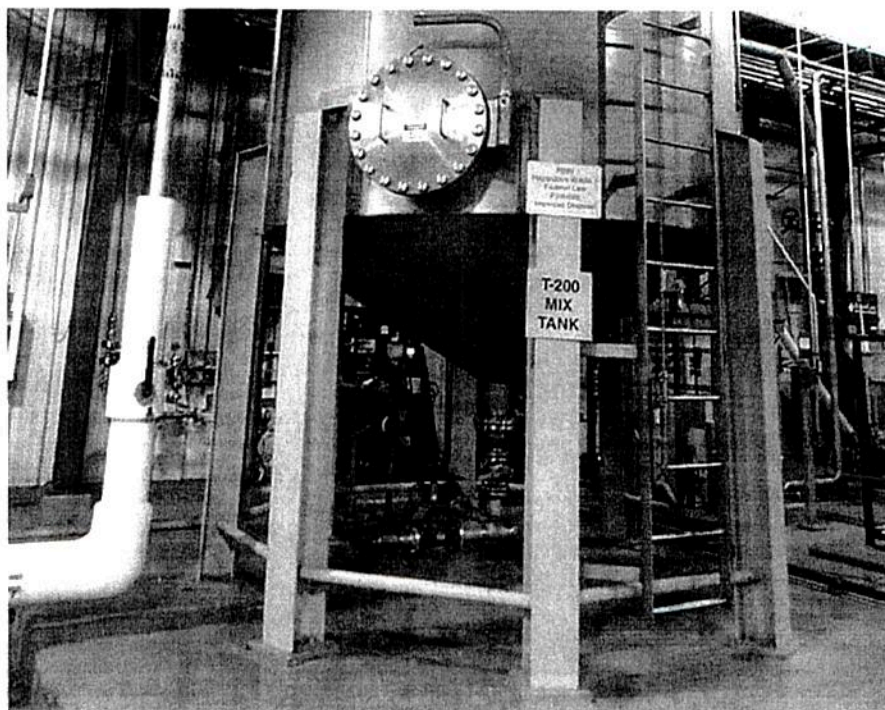
At the time of the inspection, all LTS units were properly identified and appeared to be in good condition (pictures 22 and 23). According to the facility's air permit application, all LTS units are vented directly to atmosphere via a common stack in the LTS building. Although the LTS has an air permit, the EPA recommends that the LTS be included in the Post Closure Care Permit as a Miscellaneous Unit (Subpart X) under of S.C. Code Ann. Regs. 61-79.264 [Subpart X of 40 C.F.R. Part 264 (40 C.F.R. Part 264)], and subject to Subpart CC of S.C. Code Ann. Regs. 61-79.265 [Subpart CC of 40 C.F.R. Part 265] or that it meets any of the exemptions in S.C. Code Ann. Regs. 61-79.265.1080(b) [40 C.F.R. § 265.1080(b)]. After the inspection, EPA personnel were informed that the RCRA post closure permit would be amended to include the LTS and the LTS sludge storage area.

Picture 22: Side view of Tank #200 of the Leachate Treatment System (LTS). In the tank, the leachate is treated by adjusting the pH and mixing it with a flocculant. Picture taken by Javier García on 2/22/2016, at 2:27 pm.

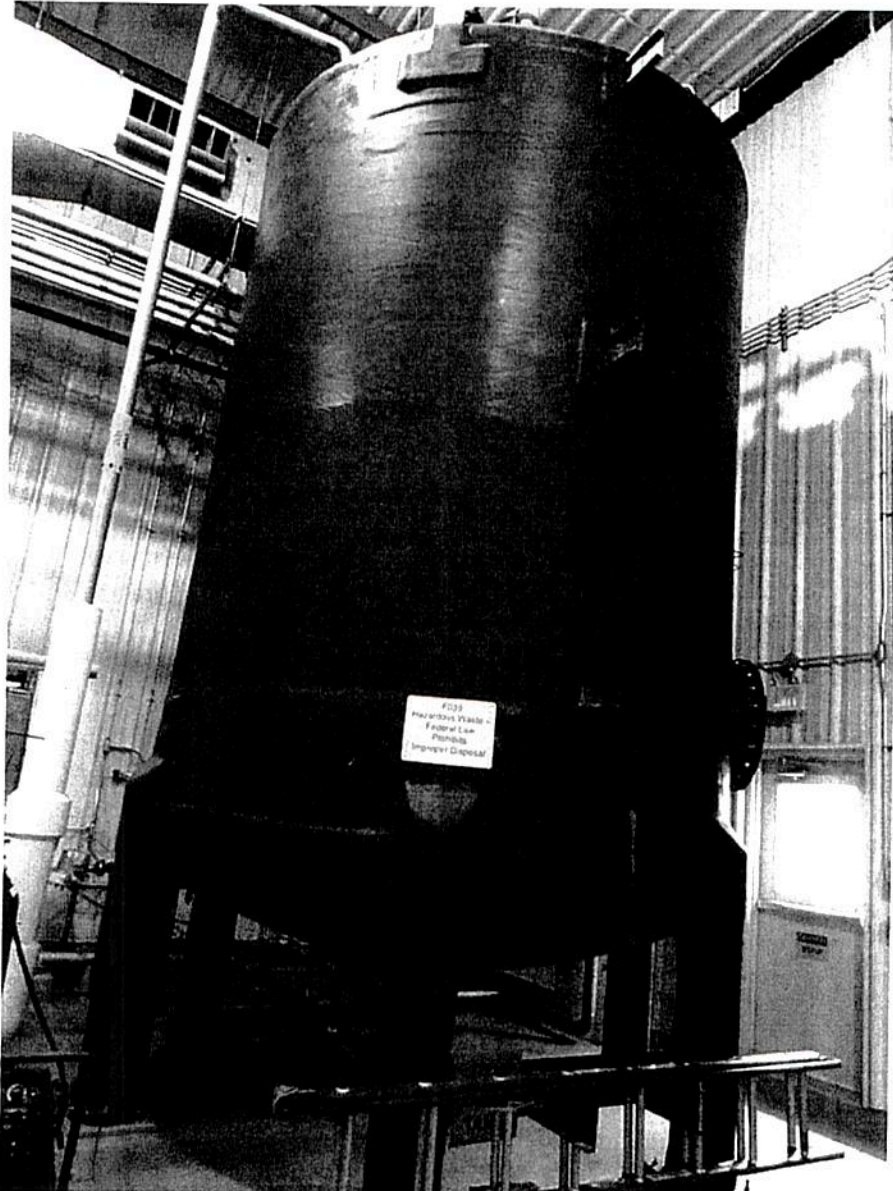
Picture 23: Side view of Tank # 210 of the LTS. The tanks receives the flocculated leachate from tank 200 and it is used as the feed tank to the filter press. The tank is marked as containing hazardous wastes. Picture taken by Javier García on 2/22/2016, at 2:28 pm.

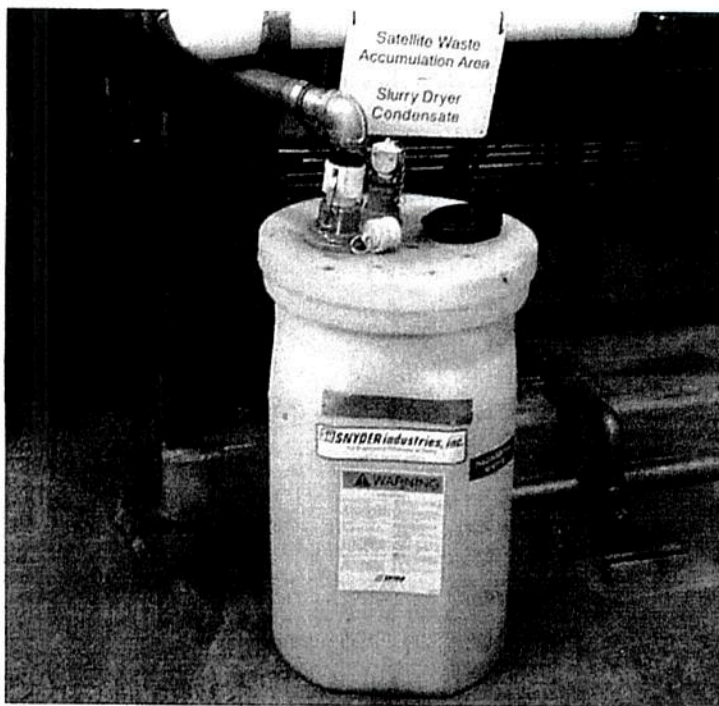
Connected to the slurry dryer, the inspectors observed a 30-gallon container identified as containing condensate from the dryer (pictures 24 and 25). The container was properly labeled, closed and appeared to be in good condition. The liquid accumulated in this container is pumped to tank T-200 via a pump (P003) in the lab area.

Picture 24: SAA container for slurry dryer condensate. The condensate is transferred to Tank #200 via pump P-300 located in the laboratory. Picture taken by Javier García on 2/22/2016, at 2:37 pm.

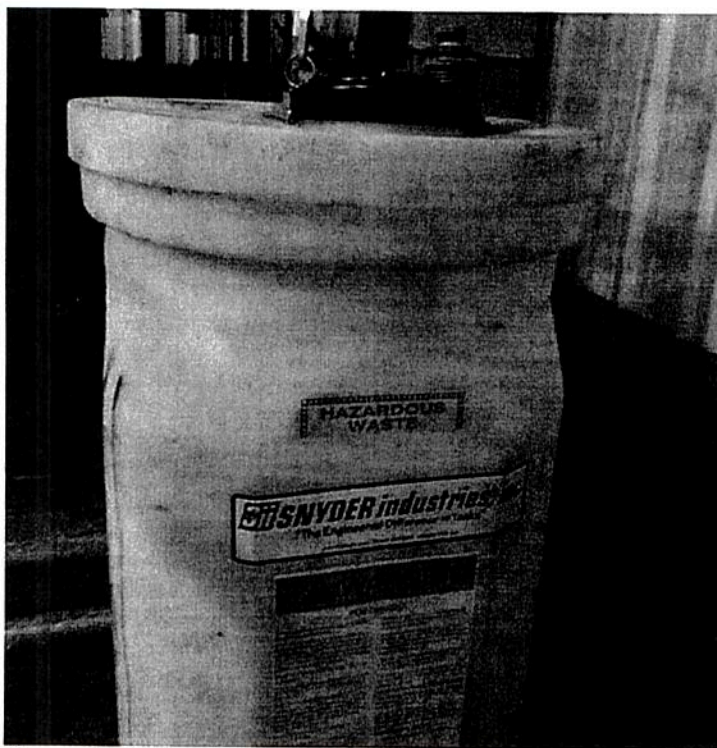
Picture 25: View of SAA container for slurry dryer condensate. The condensate is transferred to Tank 200. Picture taken by Javier García on 2/22/2016, at 2:38 pm.

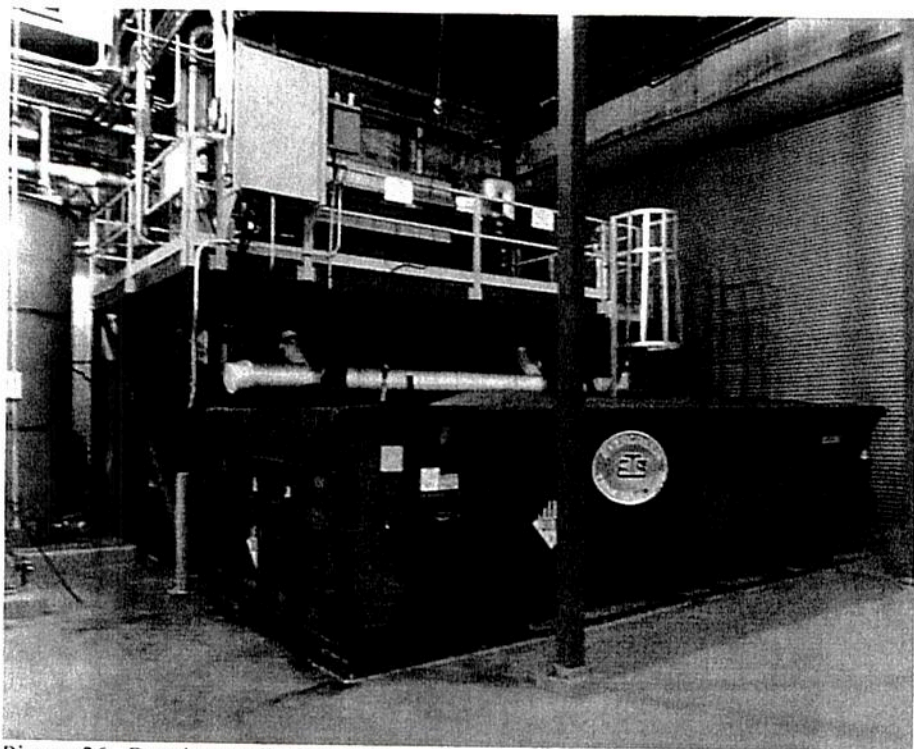
Also located in the in the LTS building, the inspectors observed two roll-off containers used for the accumulation of pressed sludge and dried slurry (picture 26). Both containers were closed, labeled, dated and appeared to be in good condition. The containers were marked with accumulation start dates of 2/20/16 and 2/6/16. Adjacent to the west side door of the building the

Picture 26: Dry slurry roll off container, adjacent to sludge filter press. The container was labeled and dated with an accumulation start date of 2/20/16. Picture taken by Javier García on 2/22/2016, at 2:42 pm.

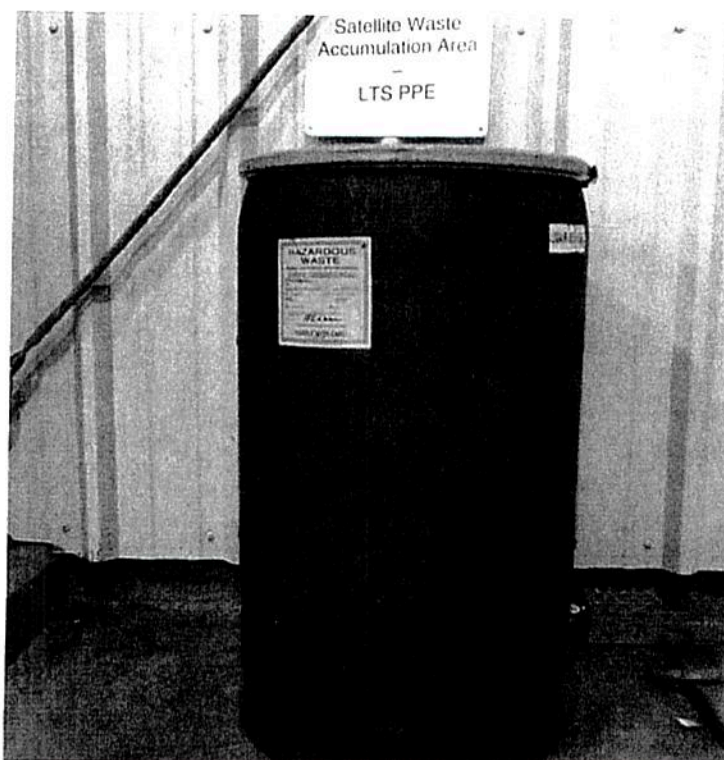
inspectors observed a 55-gallon container used for the accumulation of PPE generated in the LTS (picture 27). The container was properly labeled, closed and appeared to be in good condition.

Picture 27: SAA container for contaminated PPE generated in the LTS building. Picture taken by Javier García on 2/22/2016, at 2:45 pm.

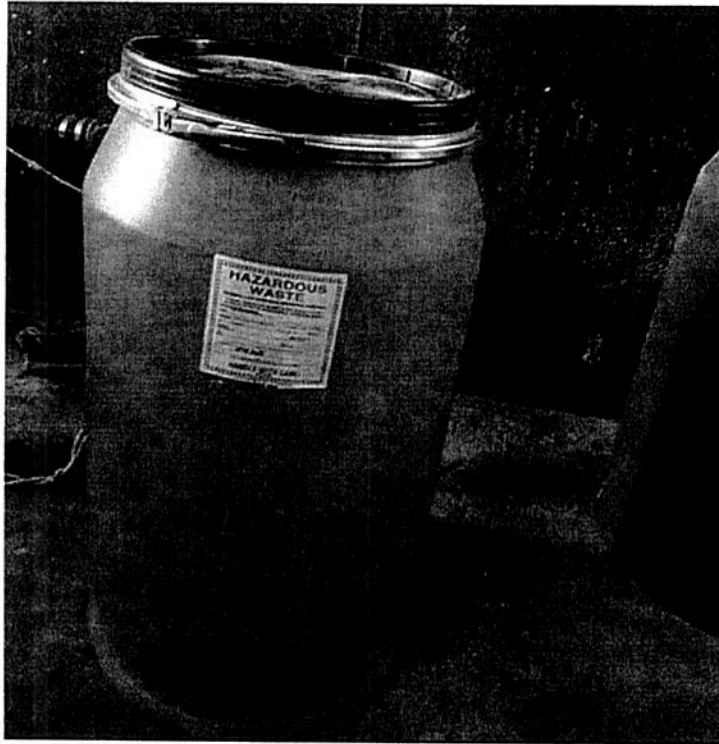
Picture 28: Non-burnable contaminated debris SAA container in the Waste Pile Building. Picture taken by Javier García on 2/22/2016, at 3:17 pm.

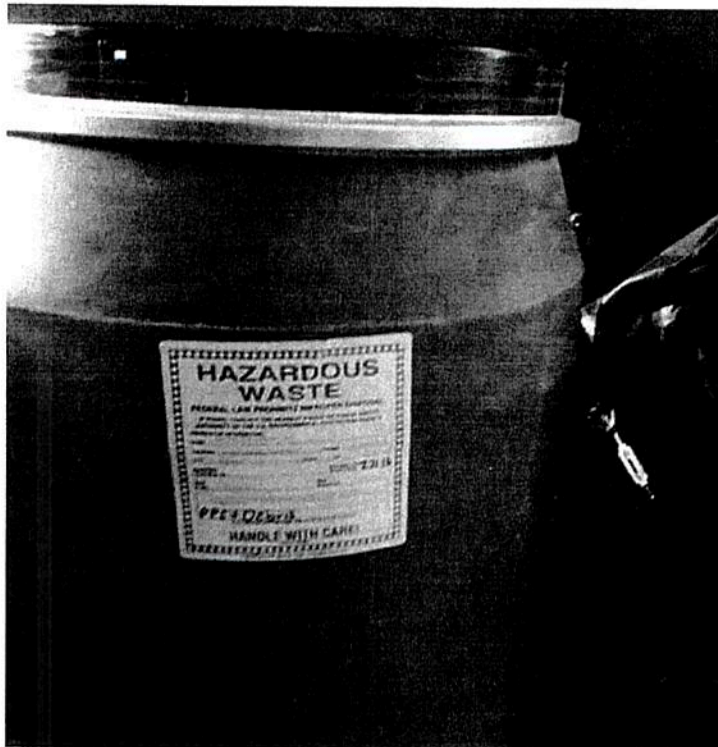
Picture 29: Burnable contaminated PPE SAA container in the Waste Pile Building. Picture taken by Javier García on 2/22/2016, at 3:17 pm.

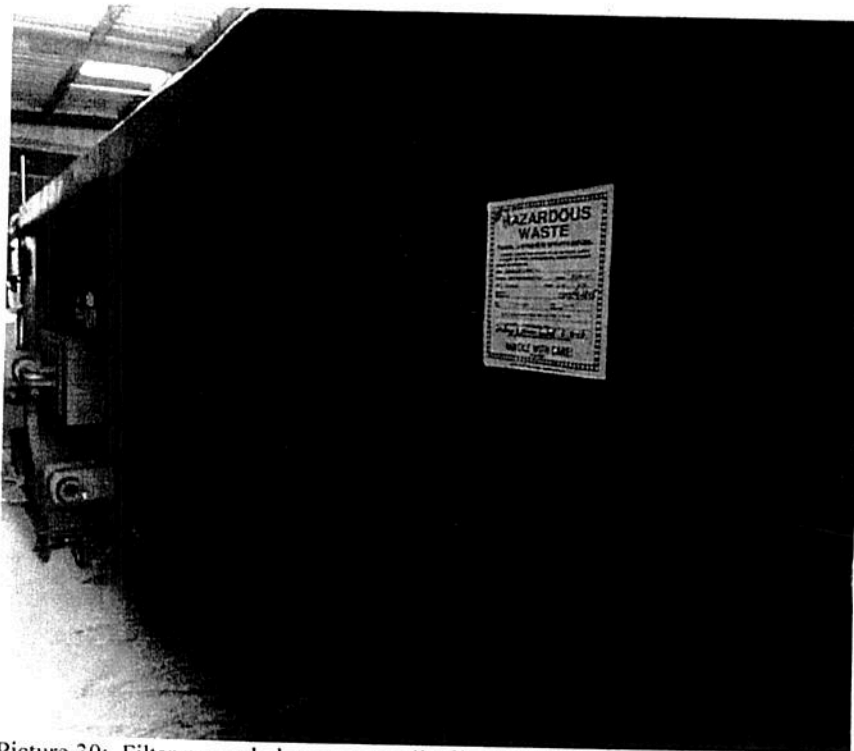
The name of the building reflects the management of hazardous waste in piles at the building when the landfill was in operation. Currently, Pinewood uses this building for storage of hazardous waste containers prior to shipment off-site. The unit is not covered by the facility's post-closure care permit; hence, storage is limited to 90-days. In the building, the inspectors observed two satellite accumulation area containers. One container was used for the accumulation of contaminated PPE and the other container was used for non-burnable contaminated debris (pictures 28 and 29). Both containers were properly labeled, closed and appeared to be in good condition. Near the accumulation containers, the inspectors observed a roll-off container reported to contain filter press sludge. The container was properly closed, labeled, dated and appeared to be in good condition (pictures 30 – 32). The accumulation start date marked on the container was 9/12/15. Mr. Burgess indicated that SCDHEC had granted two 30-day extensions for the storage of this container for longer than 90-days. The next day following the inspection, Mr. Burgess emailed the EPA a copy of the manifest documenting the shipment of this roll-off container.

Picture 30: Filter press sludge storage roll-off container in the Waste Pile Building. The accumulation start date marked on the container was 9/12/15. Picture taken by Javier García on 2/22/2016, at 3:19 pm.

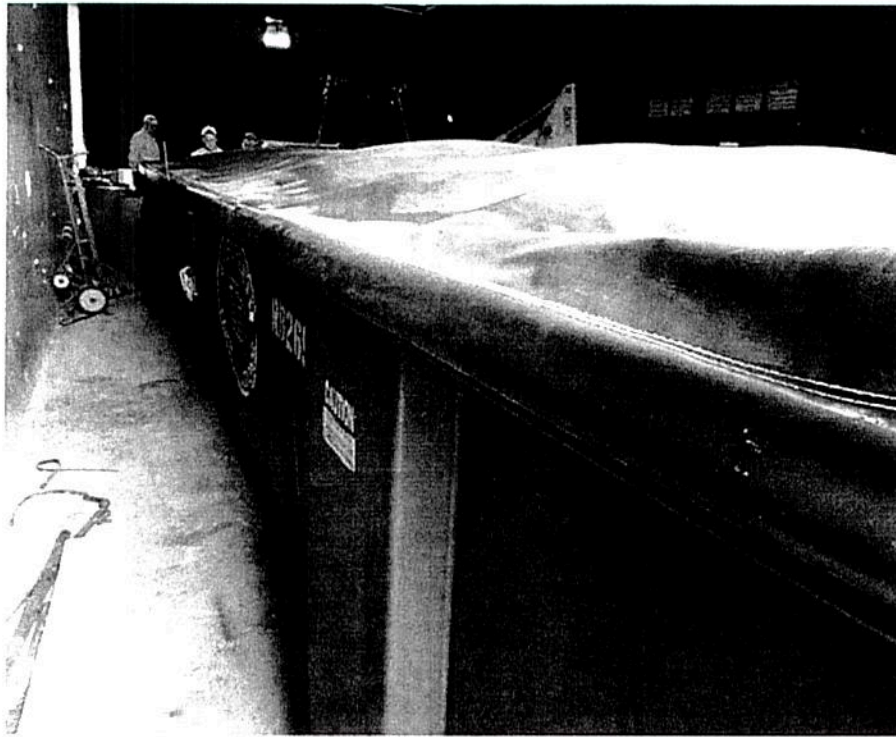
Picture 32: General view of the filter press sludge roll-off container in the Waste Pile Building. The container was marked with the accumulation start date of 9/12/15. Picture taken by Javier García on 2/22/2016, at 3:19 pm.

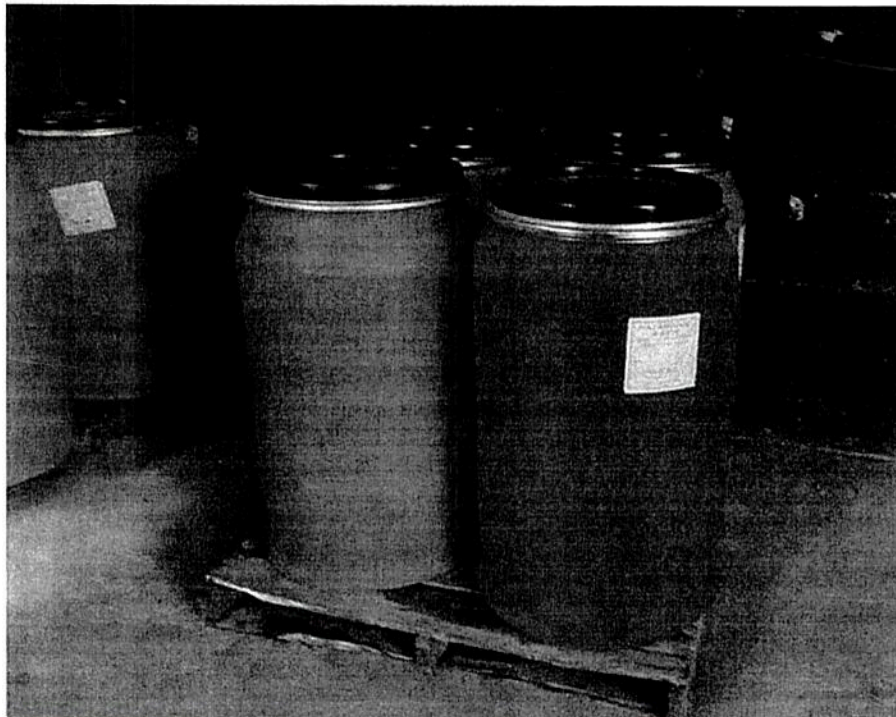
Across from the roll-off container, along the building wall, the inspectors observed ten 55-gallon containers (pictures 33 and 34). The containers were reported to contain hazardous waste contaminated debris (burnable and non-burnable). The containers were properly labeled, dated, closed and appeared to be in good condition. The oldest accumulation start date observed on the containers was 12/15/2015.

Picture 33: Waste Pile Building less than 90 days 55-gallon storage area. The oldest container was marked with the accumulation start date of 12/21/15. Picture taken by Javier García on 2/22/2016, at 3:23 pm.

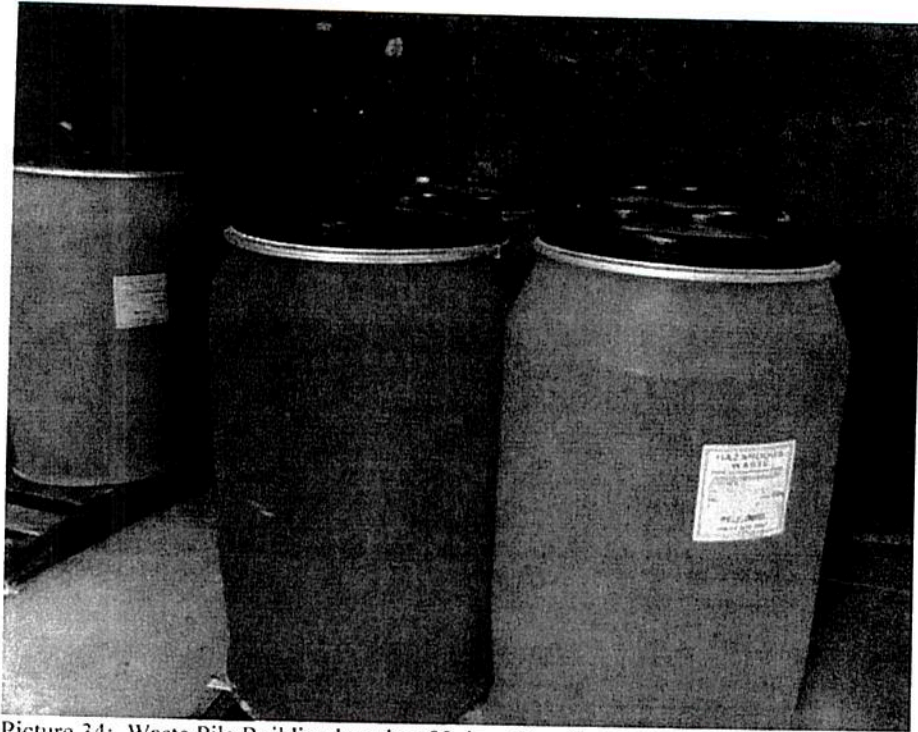
Picture 34: Waste Pile Building less than 90 days 55-gallon storage area. The oldest accumulation start date observed on the 55-gallon containers 12/21/15. Picture taken by Javier Garcia on 2/22/2016, at 3:23 pm.
